# Technical Service Bulletin

01 MIL on (rpm is restricted to 2500rpm), DTCs P191B00, P10EF00, and/or P048000 are stored in the ECM

01 20 74 2059449/1 August 5, 2020.

Model(s)	Year	VIN Range	Vehicle-Specific Equipment
S4	2019	000001 - 012603	3.0 TFSI
S5	2019	000001 - 048868	3.0 TFSI

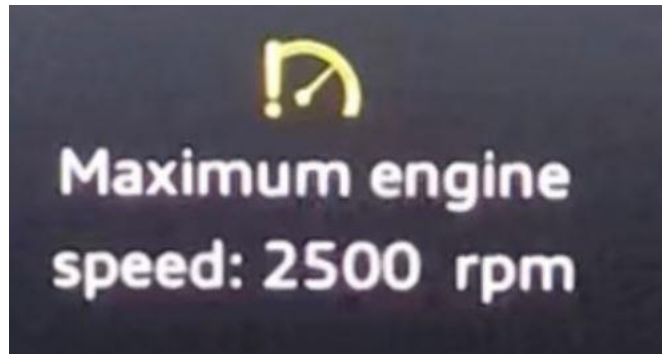
- MIL on.
- A maximum engine speed message appears in the instrument cluster (Figure 1).
- The vehicle may experience reduced engine performance.

*Figure 1. Message in the instrument cluster.*

Please thoroughly inspect the connector for the radiator fan V7. Check for any connection issues, for instance, if the connector is not correctly seated, a loose or damaged terminal, etc.
